**Flood Control Project Maintenance
Levee Inspections**

Fall 2011 Levee Maintenance Deficiency Summary Report

Levee Inspection Report By Mile - Fall 2011

Sutter Maintenance Yard Maintenance Area 0017

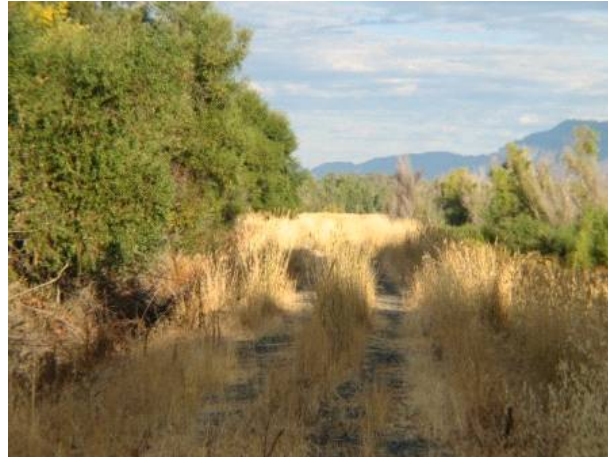
rduffey_f_20110927_447.jpg

Levee Mile Report Line	1
Start Levee Mile	4.18
End Levee Mile	7.30
Location	Water Side
Category	Earthen Levee
Item	Trim / Thin Trees

View of the trees on the waterside slope of the Levee.

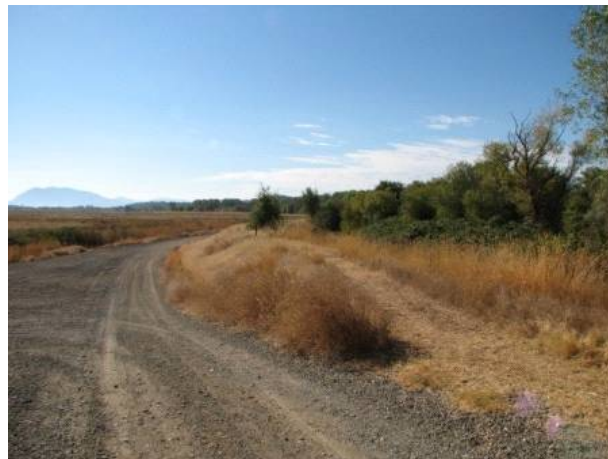
rduffey_f_20110927_446.jpg

Levee Mile Report Line	2
Start Levee Mile	4.18
End Levee Mile	7.31
Location	Water Side
Category	Earthen Levee
Item	Vegetation

View of the six-foot crown levee & heavy vegetation on waterside slope.
